The Impact of Engineering Software on Documentation & Preserving Cultural Heritage: A case Study of AL-Ghulitha Heritage Outpost in AL Muthanna Governorate

Keywords: Al-Ghulitha Outpost, heritage preservation, engineering software, AutoCAD, Sketchup, Lumion.

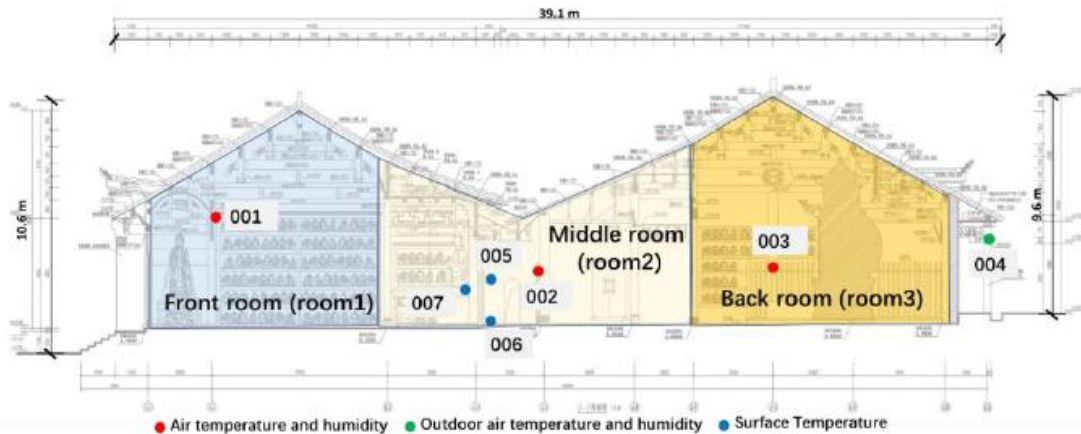
Fig. 4: Layout of environmental monitoring points [10].

Moreover, using modern and different technological engineering systems [10], environmental control systems have been used to preserve historical buildings by precisely regulating temperature and humidity. This technology relies on sensors and intelligent control systems to maintain optimal environmental conditions, and comprehensive field measurement and monitoring were conducted before developing a model of the historic built environment. Seven monitoring devices have been installed on site (Fig.1).

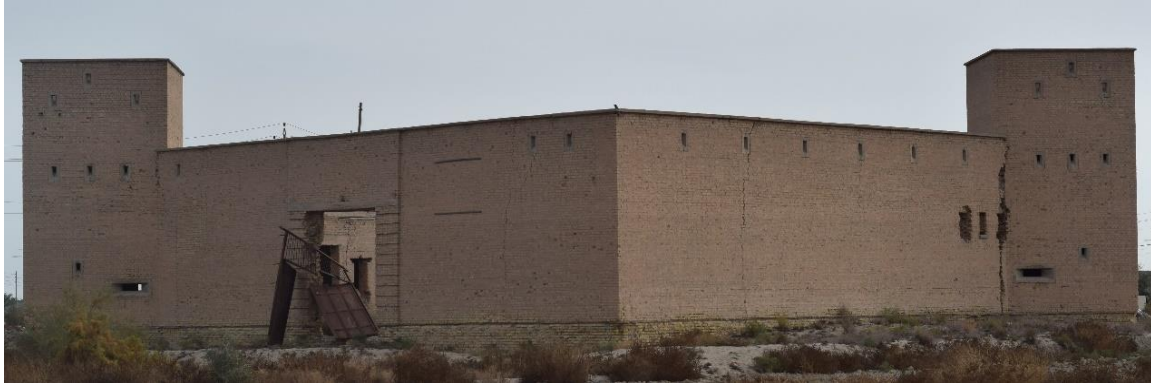
Fig. 2: Al-Ghulitha outpost (researcher)

The outpost has a rectangular-shaped building with dimensions 21.3*20.8 meters, consisting of one floor with walls height of 6.5 meters (Fig. 2).

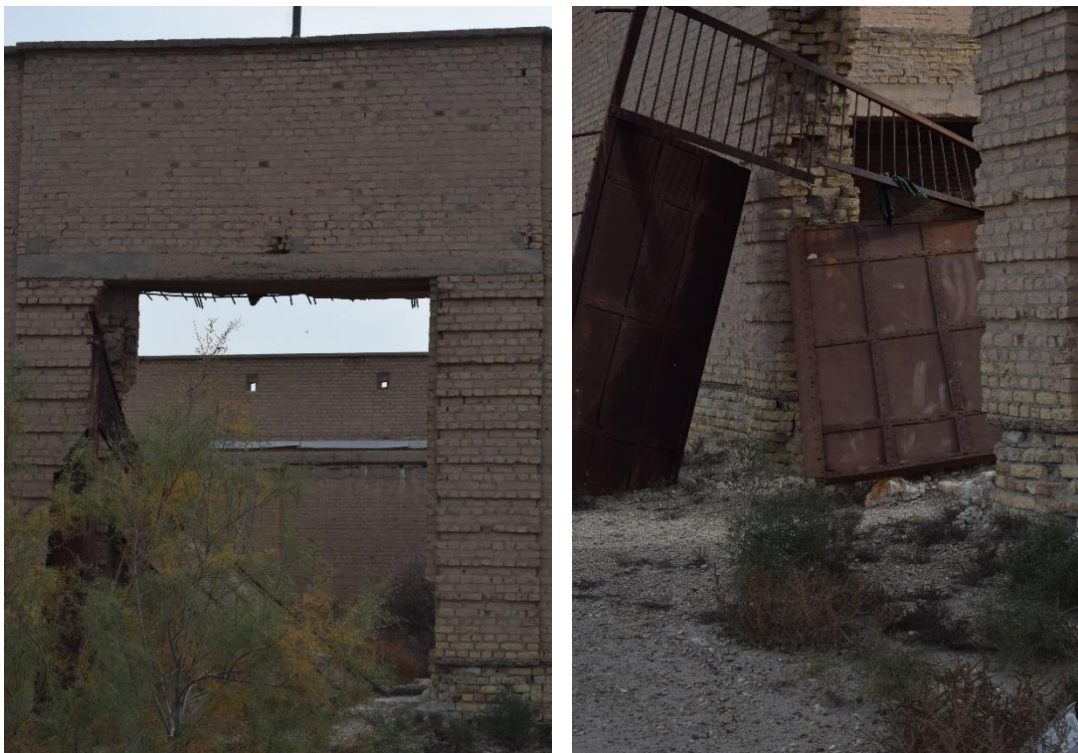
Fig. 3: Left: the only entrance to the outpost. Right: the gate (researcher)

As the building is surrounded by an open environment with no adjacent structures, the building has four facades. The entrance of the building is located on the northwestern façade, featuring prominent brick projections from the original wall (0.12 meters). The entrance width is 3.25 m, and its height is 3.65m; it contains in the middle an iron gate with two leaves, 3 meters wide and 2.65 meters high, topped with iron bars with a total number of 25 bars and height of 1 meter. From inside, there is a concrete canopy 5 meters long and 1-meter wide that provides shade for the gate guards (Fig. 3).

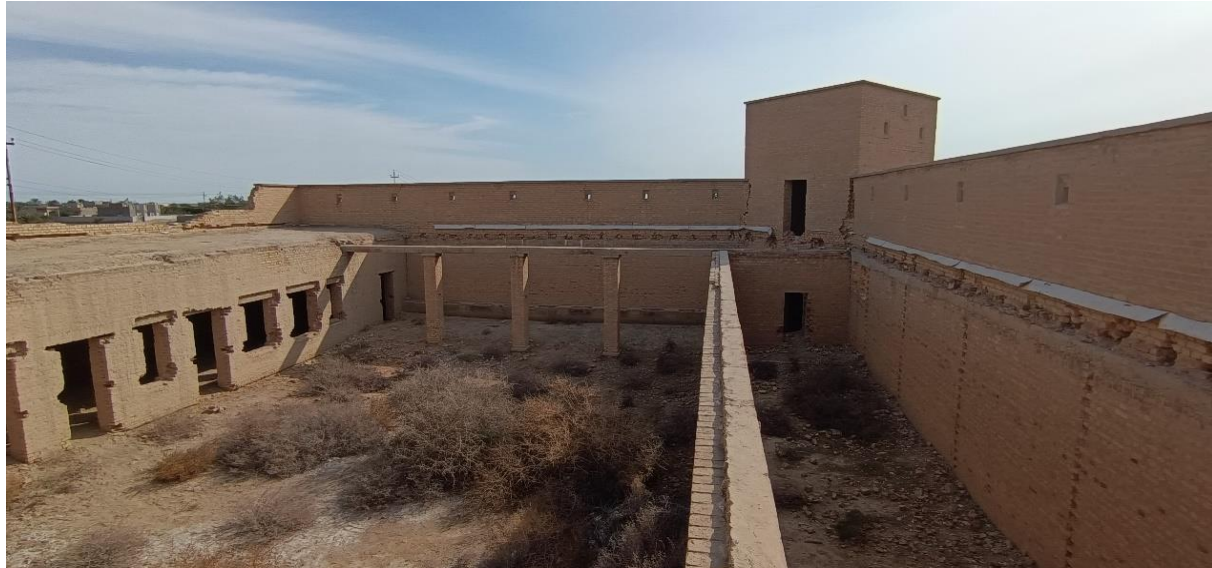
Fig. 4: The central courtyard (researcher)

The entrance to the building leads to a central courtyard overlooked by the rooms and other facilities (Fig. 4). In its eastern part, it contains a square-shaped well (0.85*0.85m) built with brick and plaster and currently buried. The police station contains remnants of rooms of various dimensions and measurements located on the northeastern and southwestern sides of the building. Its floors were paved with bricks and had openings for doors and windows. The door and window openings are topped with a concrete lintel, 0.3 m high and 0.4 m wide (. On the back side of the building, concrete basins were used as horse feeders, numbering 10 in number).

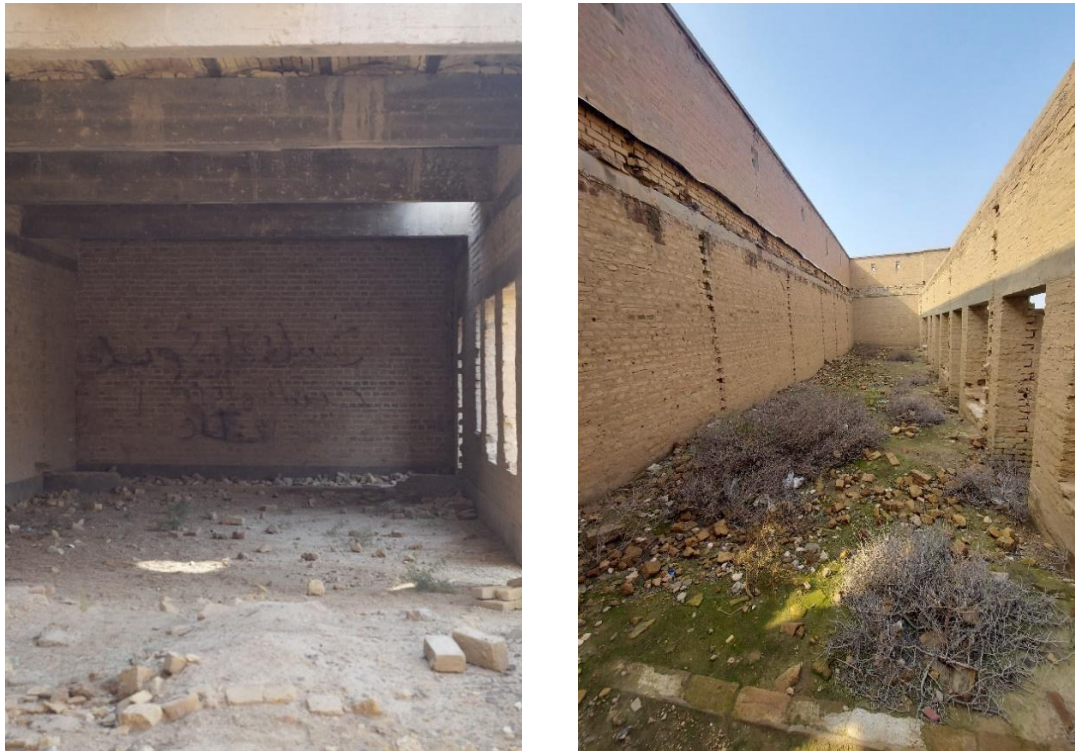
Fig. 5: left: rooms in the northeast section. Right: rooms in the southwest section (researcher)

The building was roofed using a flat slab construction method, supported by locally known iron beams called "Shilman" and bricks. The building used a semi-structural construction system, employing short-span concrete beams supporting the roof slabs. These concrete beams are supported by load-bearing walls made of 0.5m thick bricks. However, non-bearing walls 0.12 m thick of brick were used, as their function was only to divide the rooms architecturally and had no structural role (Fig. 5).

of the then-ruling regime, residents of the area attacked the police station, and the metal cover that was covering the southeastern wing (the stable) was stolen. The bricks used to build the walls separating the rooms in the north-eastern and south-western parts were also stolen (Fig. 5) [14].

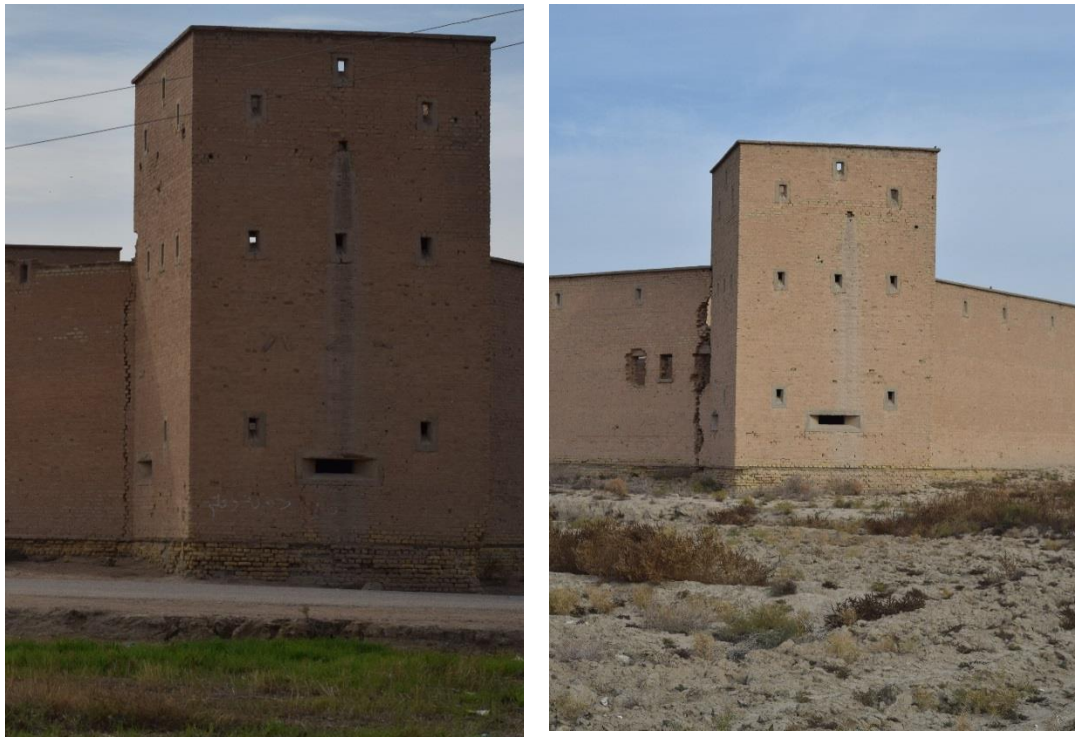
Fig. 6: left: the northern watchtower. Right: the southern watchtower (researcher)

One of the distinctive elements of the building is the presence of watchtowers in the northern and southern corners of the building, rectangular in shape, with a length of 5 m, width of 4.6 m, and height of 8.4 m. Each tower consists of two floors separated by a roof. Their roof has a square opening with an iron ladder at the bottom. On the ground floor of both towers, there is a concrete terrace adjacent to its three outer walls that was used as a dining table for the soldiers. Each tower contains several embrasures known locally as (Mazaghil), which are openings used for defensive purposes found in many parts. They had two styles; the first one was vertical in shape, with dimensions of 0.12 * 0.25 m from inside and from outside 0.6 * 0.3 m, While the other one was horizontal, and its dimensions were 1.45*0.6 m from outside and 65*25 m from inside. Several embrasures are distributed at the top of all the external walls of the outpost, except for the facade wall, which contains only one embrasure (Fig .6). The protrusion of the building entrance surrounding the gate forms a distinctive architectural feature. It was constructed with bricks, arranged in a staggered pattern every three rows, with each level followed by a single row at a different level, entering towards the gate horizontally. What also distinguishes it is the construction method and the consistency of dimensions and spacing on both sides, as shown in Figure 1.

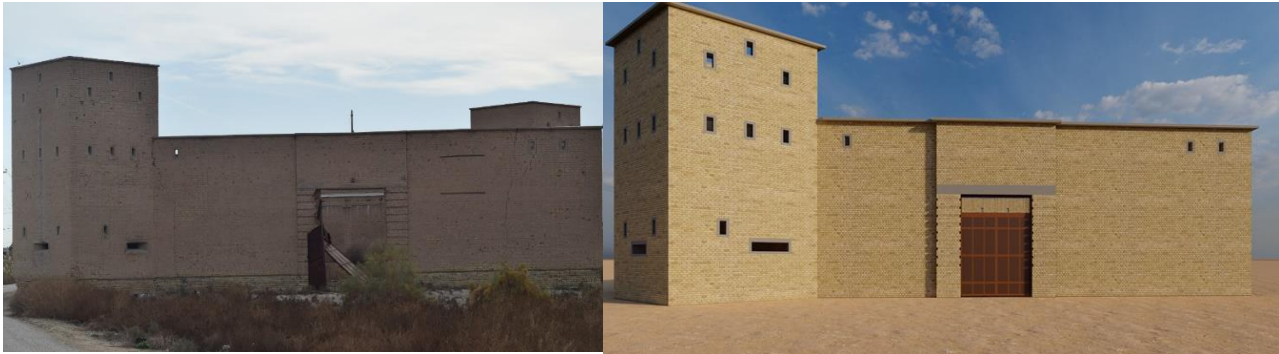
Subsequently, this model was exported to Lumion 2022 to adjust materials on the model and render it for export as images. These pictures illustrate how the police station looked before it was damaged. When comparing these images with reality, it is possible to know exactly which parts the damage affected the most and what the police station would look like if this damage were treated. Figures (9,10,11) illustrate some of these images.

Fig. 9: The north-western façade of the building. Left: reality shape. Right: Imaginary Shape (researcher)

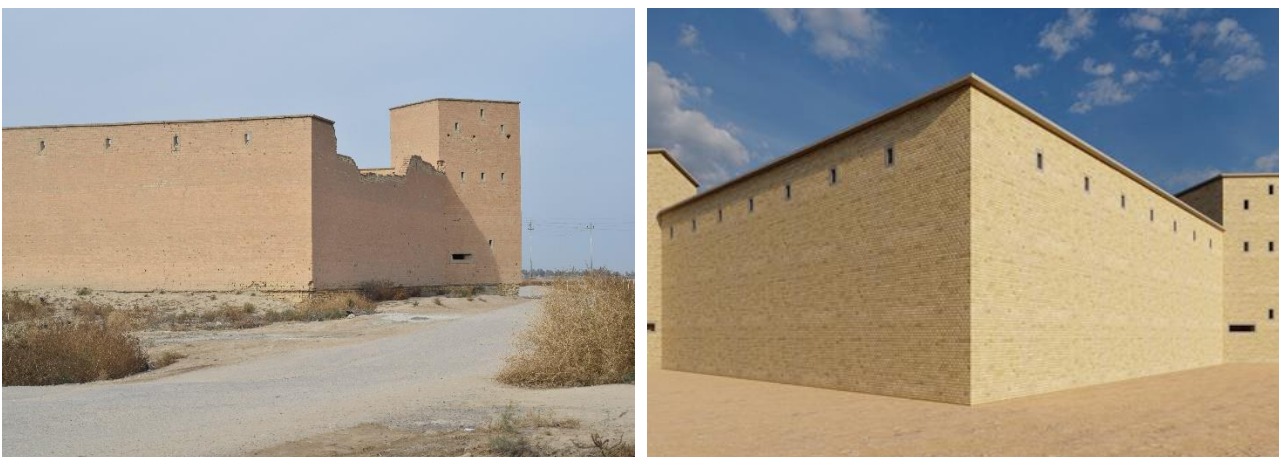
Fig. 10: The south-western facade of the building. Left: reality shape. Right: Imaginary Shape (researcher)

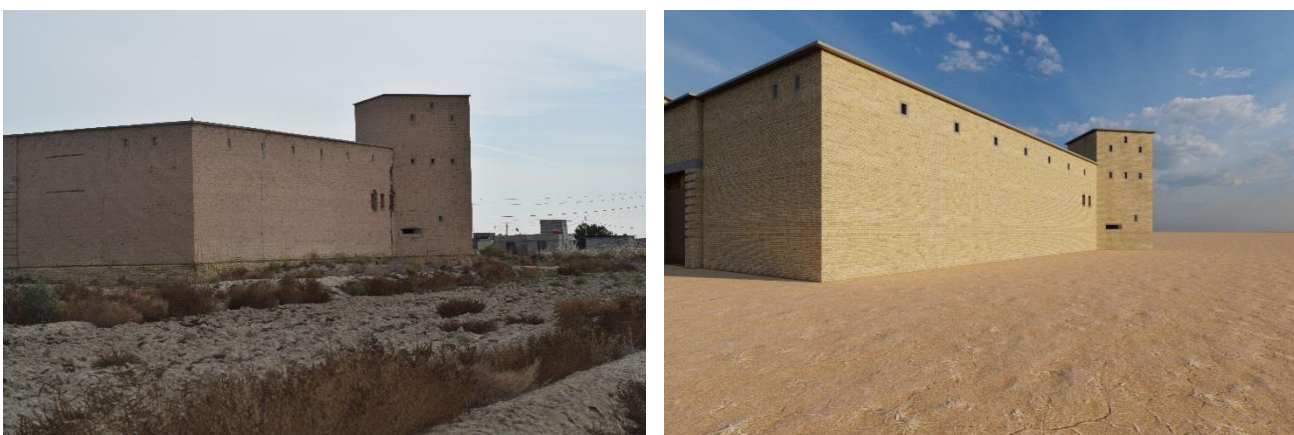
Fig. 11: The north-eastern facade of the building. Left: reality shape. Right: Imaginary Shape (researcher)
